# Piledriver and 23 Mile Slough Survey Report 2015

Tanana Valley Watershed Association

January 27, 2016

# Piledriver Slough Beaver Activity Survey Report 2015

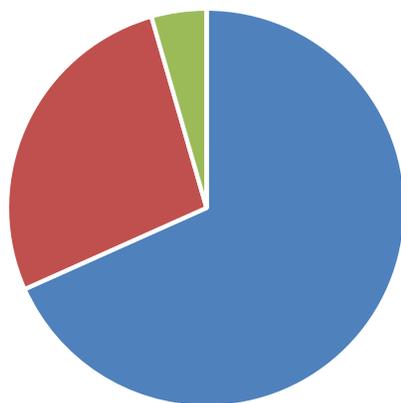
Species Diversity in Piledriver Slough 2015

■ Lake Chub ■ Slimy Sculpin ■ Arctic Grayling ■ Chum Salmon

The most commonly caught fish this year was the lake chub. We caught the majority of the Lake Chub on upper Piledriver section and 23 mile slough in June when water levels were low, temperatures were warm, and these fish may have been spawning. In past years, the Slimy Sculpin has been the most commonly caught fish in each year of sampling on Piledriver slough.

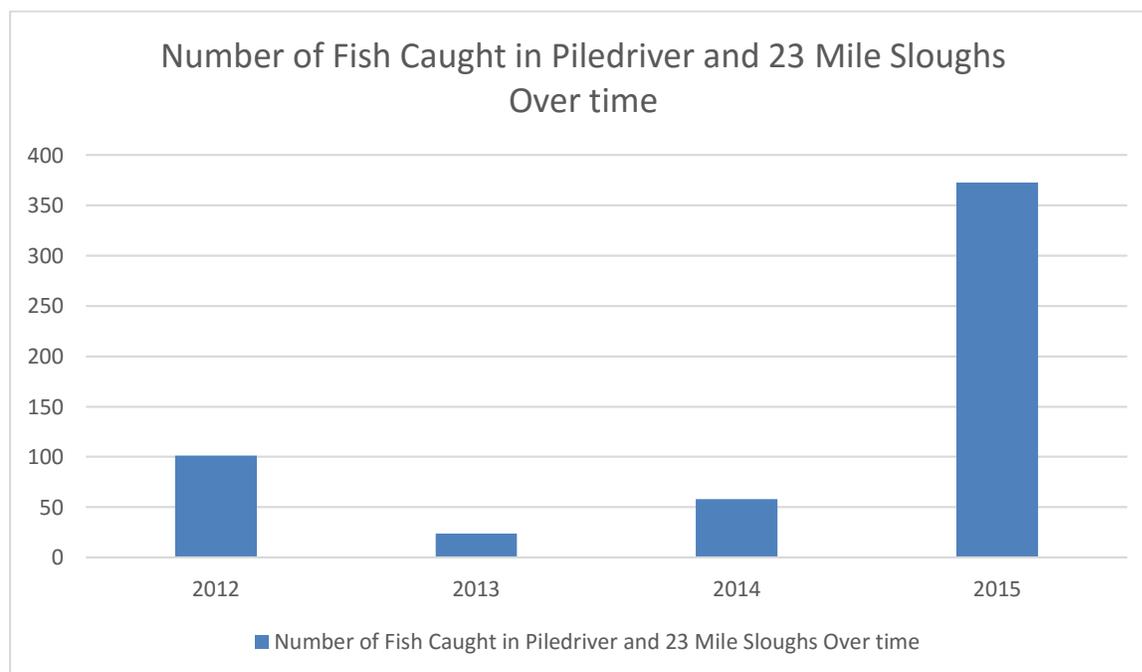
**Figure 2: Number of Juvenile Fish Caught in Piledriver and 23 Mile Slough Annually**

In 2015 we caught more fish on Piledriver slough than any other previous year. In 2014 the total catch was 58, 2013 saw 24 fish and in 2012 101 fish were captured. This is due largely to the abundance of Lake Chub that were captured in June of 2015 in Upper Piledriver and 23 mile slough. There is not yet enough data to determine a significant trend in fish numbers.

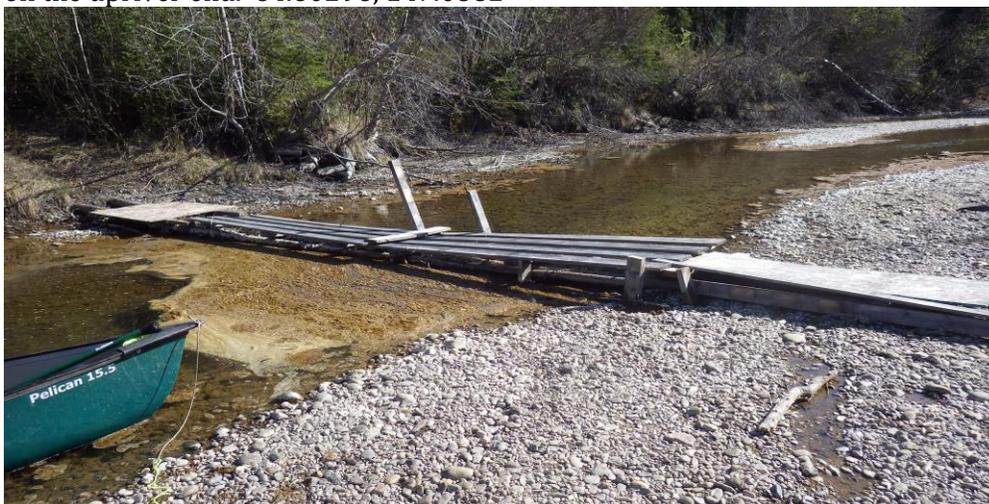
**Site 1: LB151-** Man-made bridge. Height in May was 1 foot, June 3 inches, disassembled in August. Thought to be of concern in May when a large amount of algae and fish were observed on the upriver end. 64.60296, 147.0882

Since no active beaver activity was noted, TVWA recommends no action be taken to remove dams or lodges. All dams or lodges surveyed appeared to be old, abandoned or inactive.

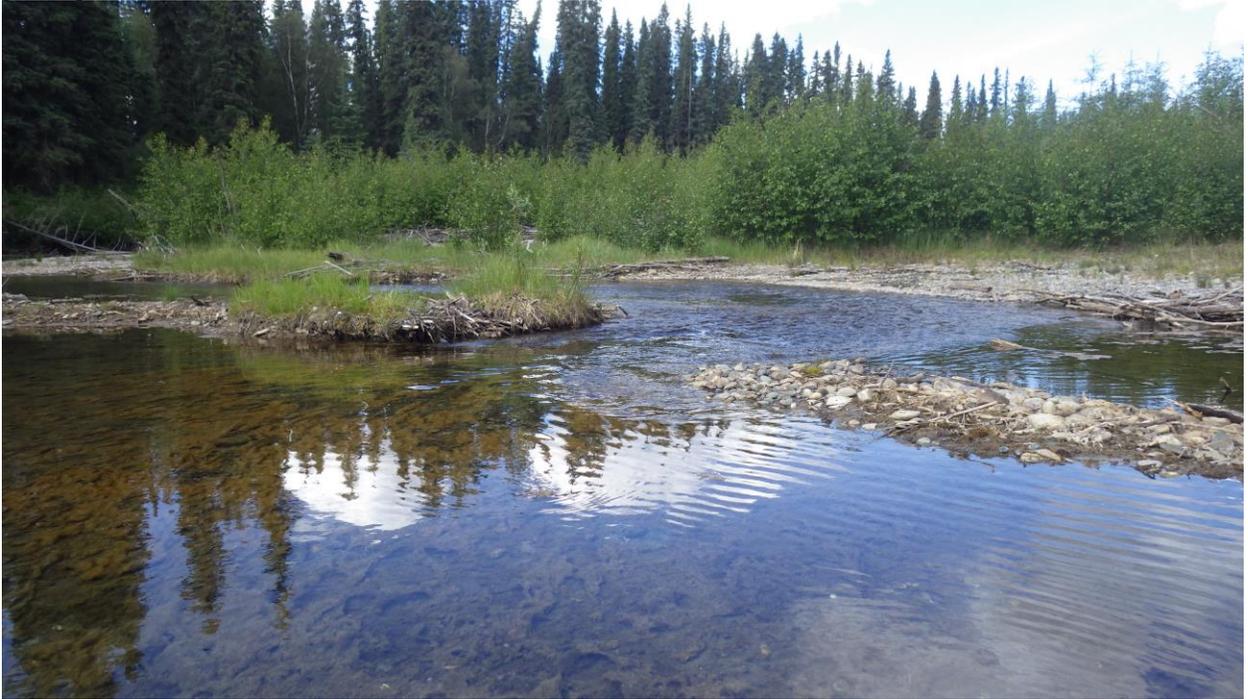
**Site 2: LB152-** Old dam with woody debris buildup. This is an old dam that has naturally built up sediment and woody debris so that it ranges from 1-2 feet in height. Not a concern because passage also varies between 2-4 feet. 64.60339, 147.08543

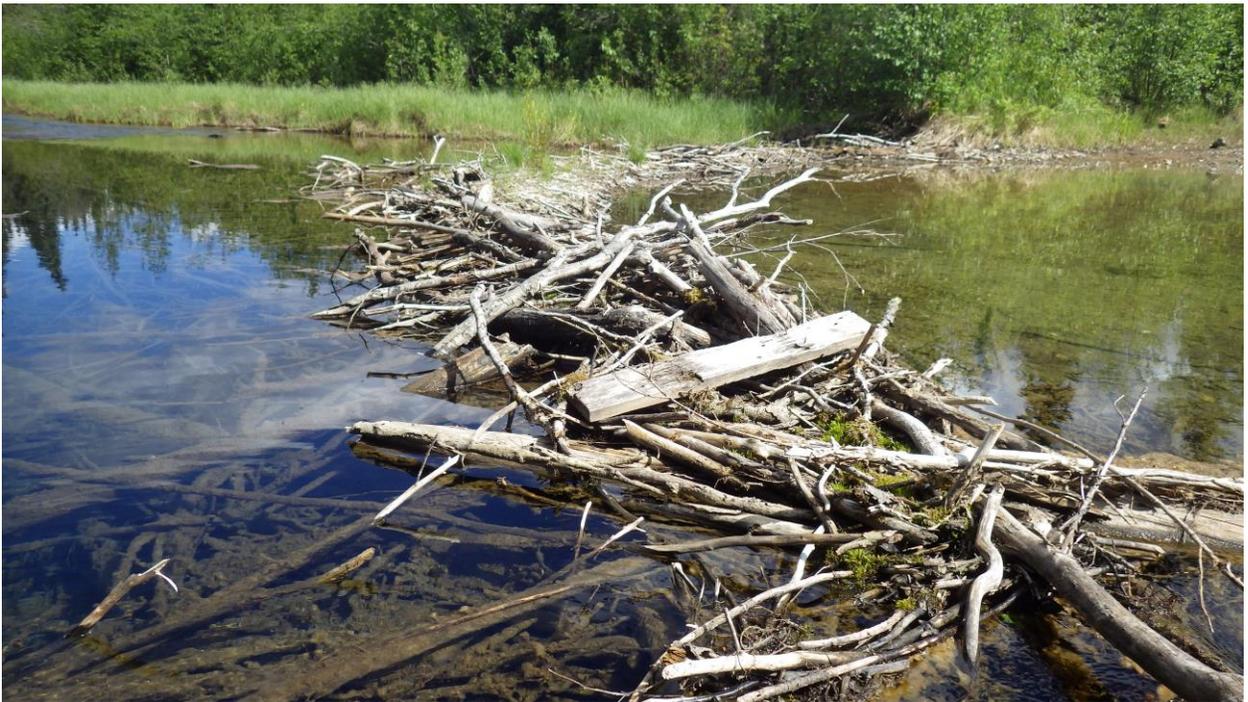
**Site 3: LB153-** Short dam. Height ranged from 6in to 1 foot, passage ranged from 2.5-5 feet. Made of smaller diameter logs, not a concern for fish passage in 2015. 64.60551, 147.08684

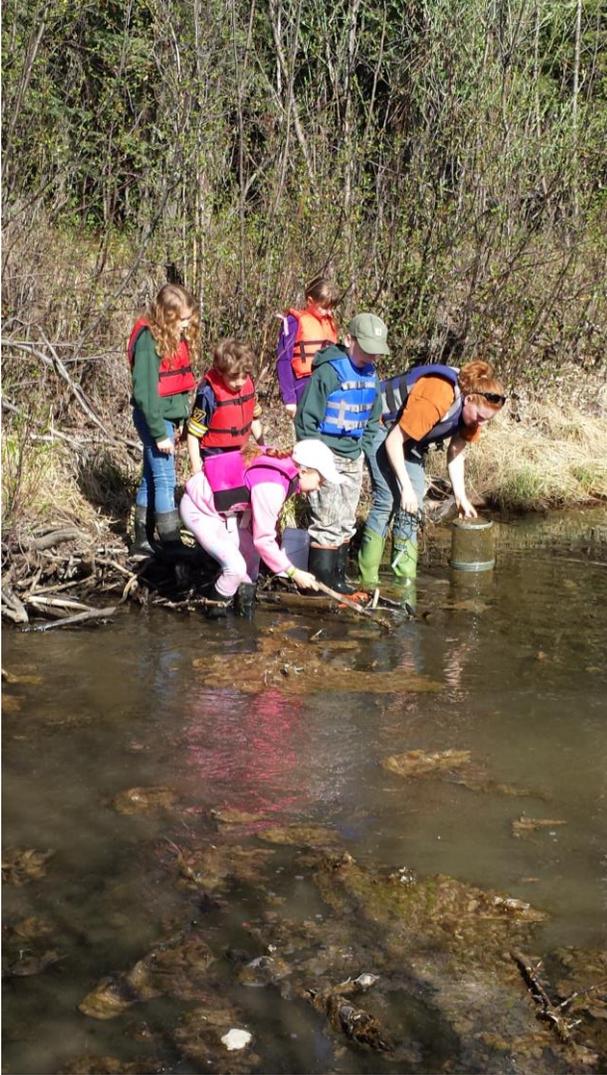
TVWA's Jenna Hertz shows a group of students how to check minnow traps for fish and then shows a student how to take water quality data using a Hanna Meter

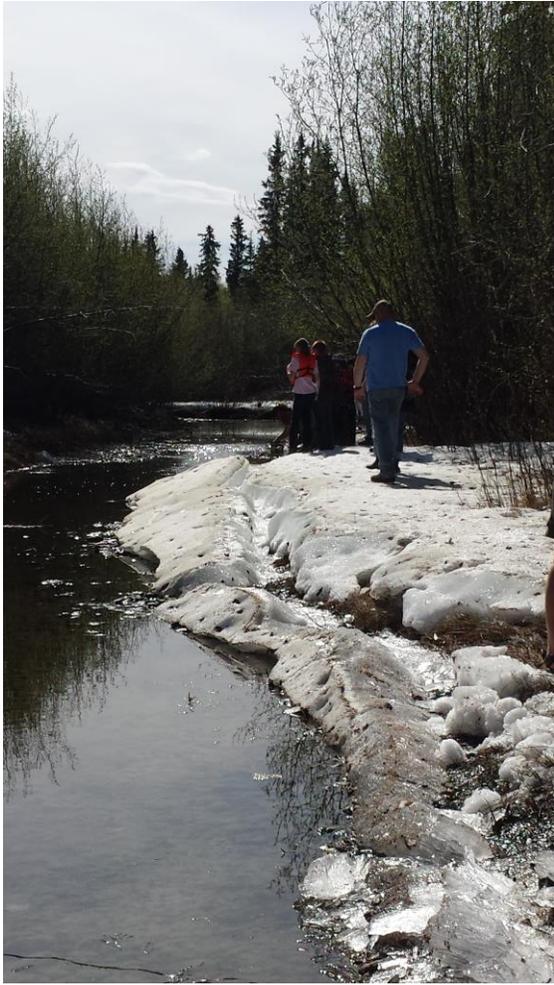
Aufeis and snow along Piledriver slough during May sampling

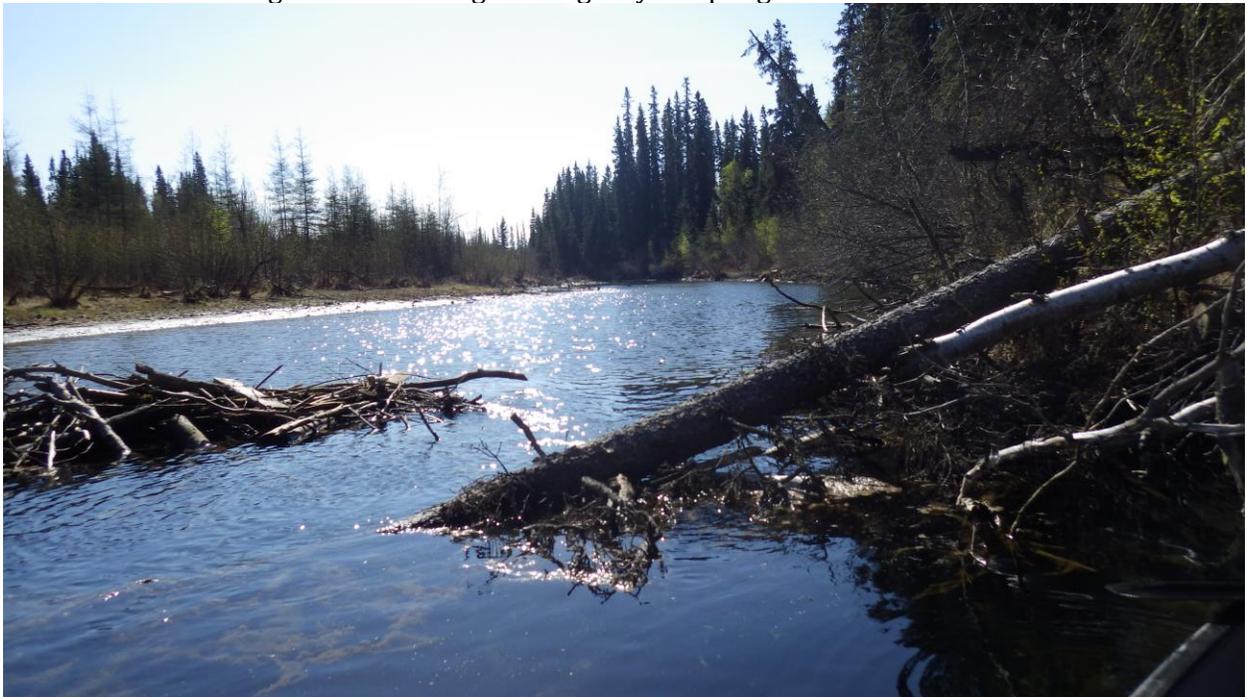
Old dam site on lower Piledriver in May.

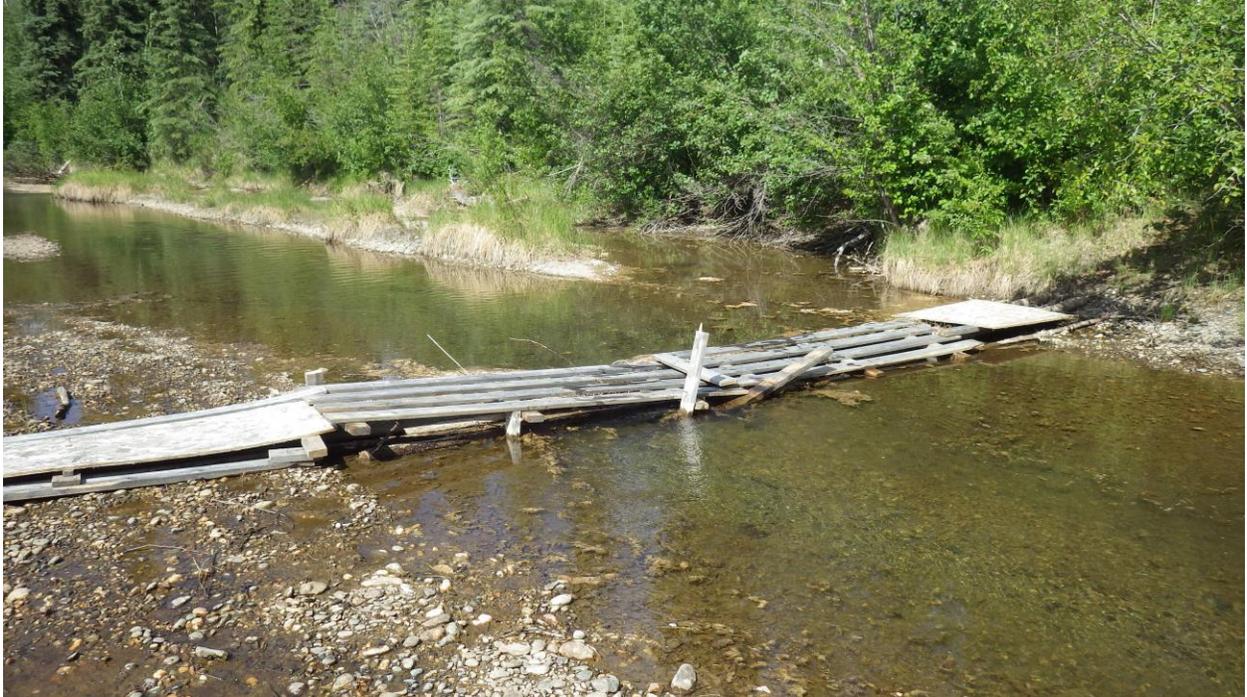
Man-made bridge during June sampling.
